Preserving History at Camp Mabry

A complete renovation of the century-old Building 1 at Camp Mabry required special precautions and flexibility throughout design and construction to accommodate a modern mission while preserving priceless historical elements.

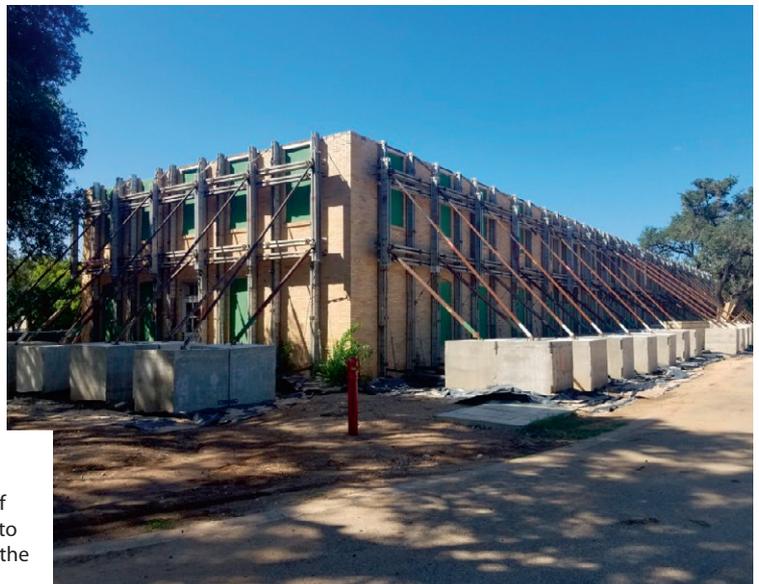
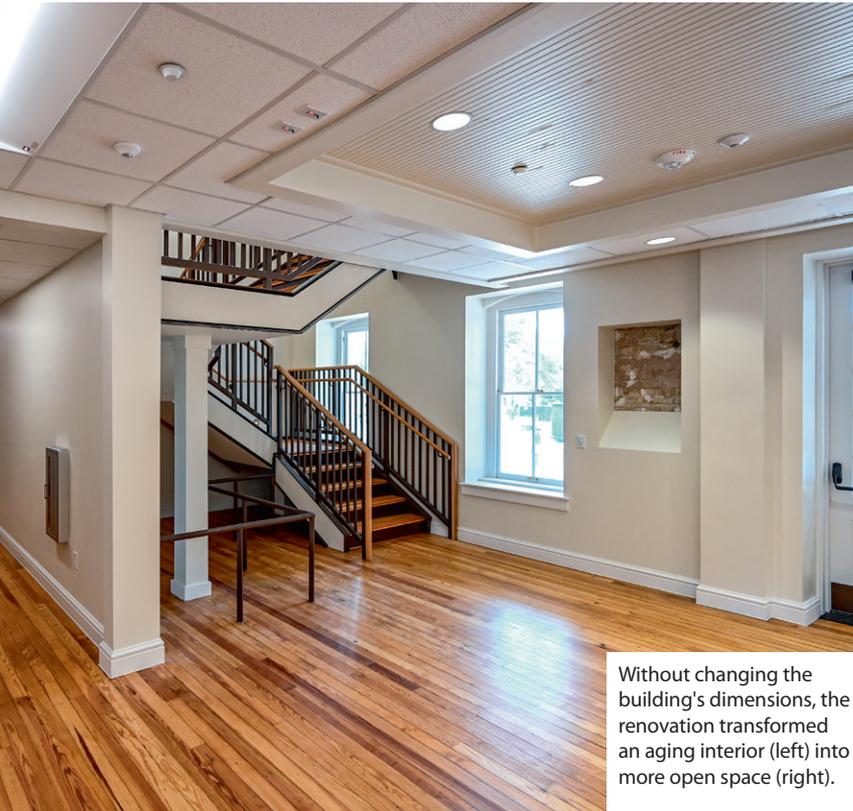
Without changing the building's dimensions, the renovation transformed an aging interior (left) into a more open space (right).
