Preserving History at Camp Mabry

A complete renovation of the century-old Building 1 at Camp Mabry required special precautions and flexibility throughout design and construction to accommodate a modern mission while preserving priceless historical elements.

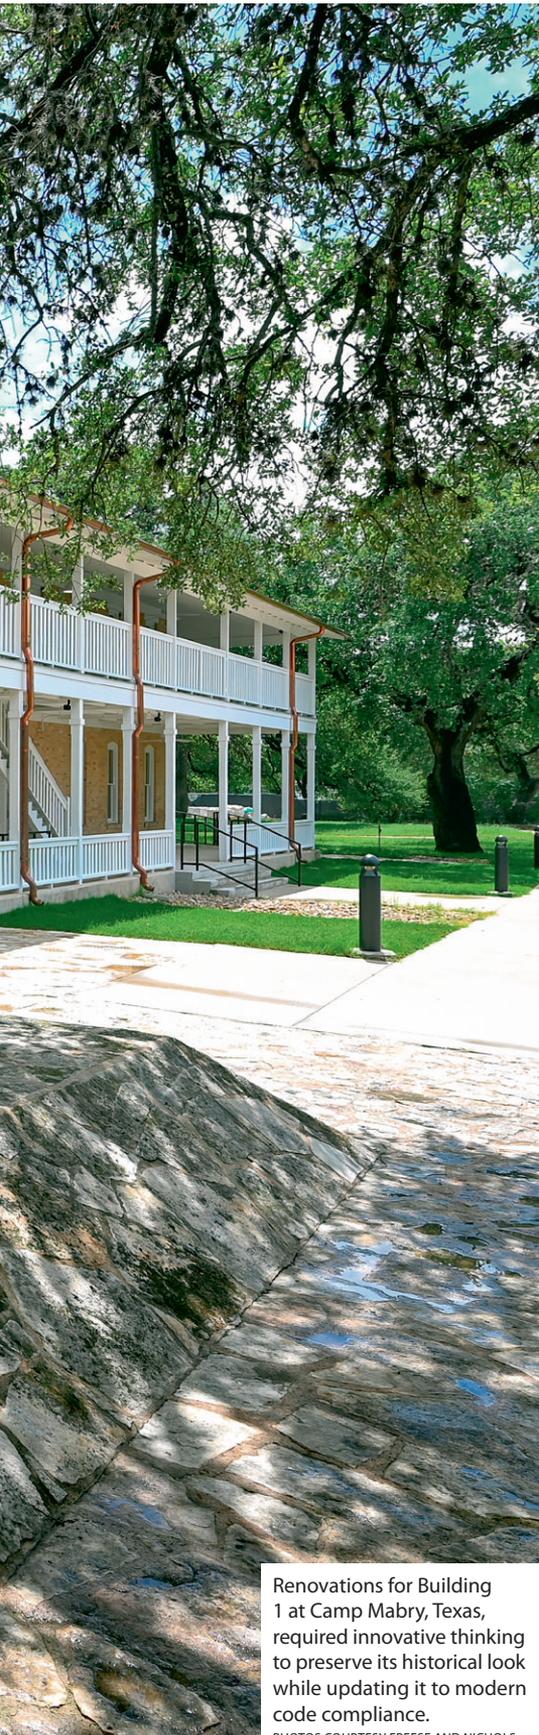
Renovations for Building 1 at Camp Mabry, Texas, required innovative thinking to preserve its historical look while updating it to modern code compliance.
